**Investigation of Septic Leachate to the Shoreline Area of
Whitefish Lake, Montana
RRG-11-1474**

Final Report

1 March 2012

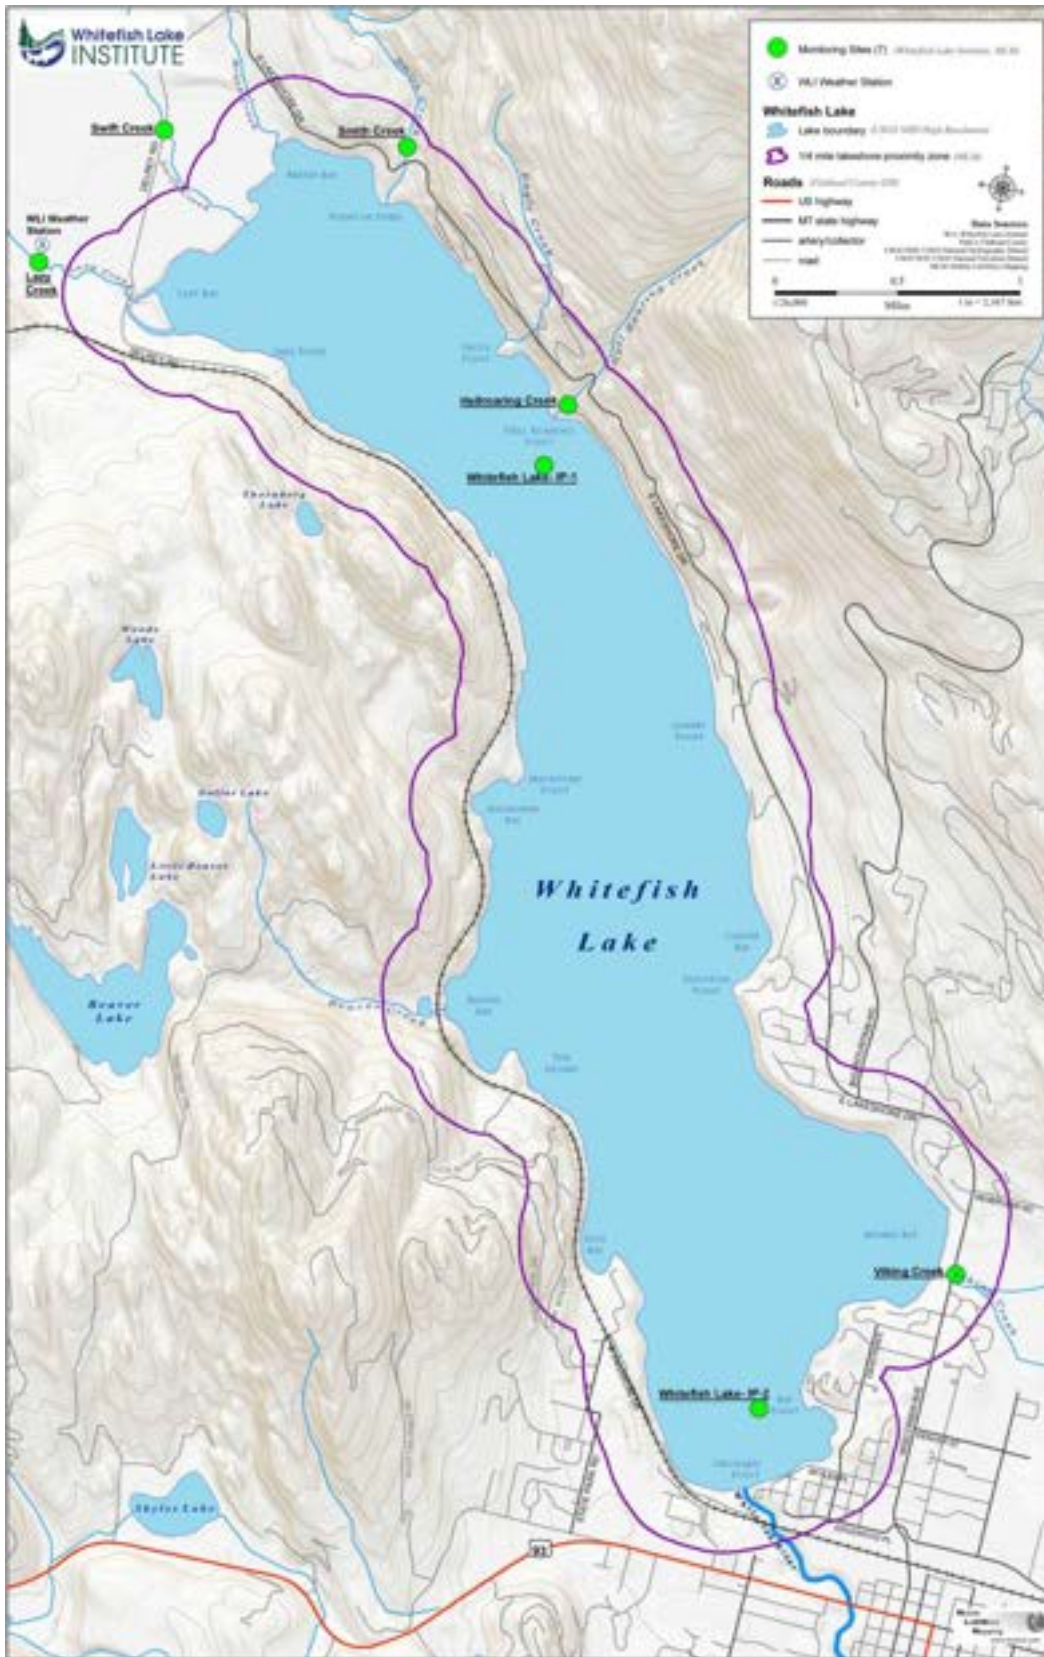
Figure 6. WLI Monitoring Sites on Whitefish Lake & Tributaries

WLI formed in 2005 with the objective of implementing a long-term Whitefish Lake Water Quality Monitoring Program. The goal of the program is to provide a comprehensive understanding of the lake resource by consistently gathering physical, chemical, and biological data for the lake and its tributaries over time and to gain an

understanding of Whitefish Lake watershed processes. While the program takes into account past studies, it offers a higher level of consistency and coordination, a baseline data set, and an integrated long-term analysis of the lake. WLI monitors two sites on Whitefish Lake along with five tributaries (Hellroaring Creek, Lazy Creek, Smith Creek, Swift Creek, and Viking Creek) (Figure 6) and two sites on the Whitefish River. Monitoring of Swift Creek is done in partnership with DNRC. Chemical sampling includes total organic carbon (TOC), total phosphorus (TP), total persulfate/nitrogen (TPN), total suspended solids (TSS), soluble reactive phosphorus (SRP), and a standard Hydrolab profile using a DS5 Sonde. This profile includes sample date, time, temperature (°F), water depth (m), conductivity (aeS/CM), resistivity (ke-cm), salinity (ppt), total dissolved solids (TDS), pH, oxygen reduction potential (ORP), luminescent dissolved oxygen (LDO) (% sat), and LDO (mg/l). Tributary sampling also includes measuring stream flow and developing stage discharge relationships. Atmospheric bulk loading data (wet and dry) is collected from the Weather Station WLI installed and maintains near Lazy Creek. Data collected includes ammonia (NH₃), nitrates (NO₃), nitrites (NO₂), and total phosphorus (TP).

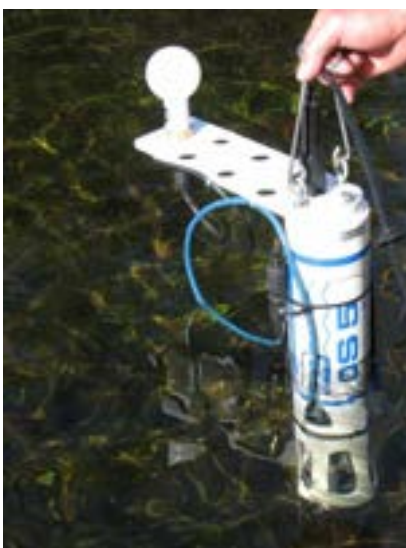
Photo 2. Hydrolab® DS5 Sonde

Septic leachates are known to contain elevated concentrations of both organic and inorganic compounds (Canter and Knox, 1985). Study area water samples were therefore analyzed using a combination of techniques, including; fluorometry, dissolved organic carbon (DOC), fluorometry/DOC ratio (F/DOC), *E. coli* enumeration, human DNA biomarkers, conductivity, and total dissolved solids (TDS). The location and density of the wastewater systems also influences the functionality of those systems. GIS methodologies and tools were consequently employed to analyze those data sets in the study area. See Section 2.2 for additional information on techniques and analytes.

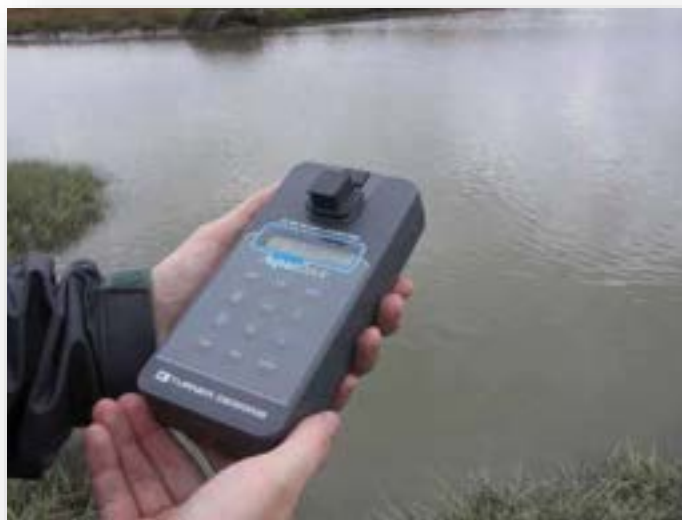
Photo 3: *Aquaflor* Handheld Fluorometer

In situ fluorometry was conducted using an *Aquaflor* handheld fluorometer (Turner Designs, Sunnyvale, California) set by the manufacturer to detect the specific light spectrum emitted from long wavelength Optical Brightener Agents (OBAs) found in domestic cleaning products.

The *Aquaflor* Handheld Fluorometer (Photo 3) is pre-set with a filter to detect UV445 (+/- 7.5) giving an optimal reading range of 437.5 to 452.50. By restricting the emission filter to this wavelength range, the resolution to detect optical brighteners from background fluorescence is optimized (Hartel *et al*, 2007). Human fecal contamination studies conducted in 2007 showed that adding a 436 nm filter to a non-filtered fluorometer, resulted in reducing background fluorescence from natural organic compounds by >50% (Hartel *et al*, 2007).

Fluorometric calibration was conducted using a solution of 1% household detergent containing a known whitener compound (Tide, Procter and Gamble, Cincinnati, Ohio), and a DI water base. Fluorometer results are reported in Relative Fluorescent Values (RFVs).

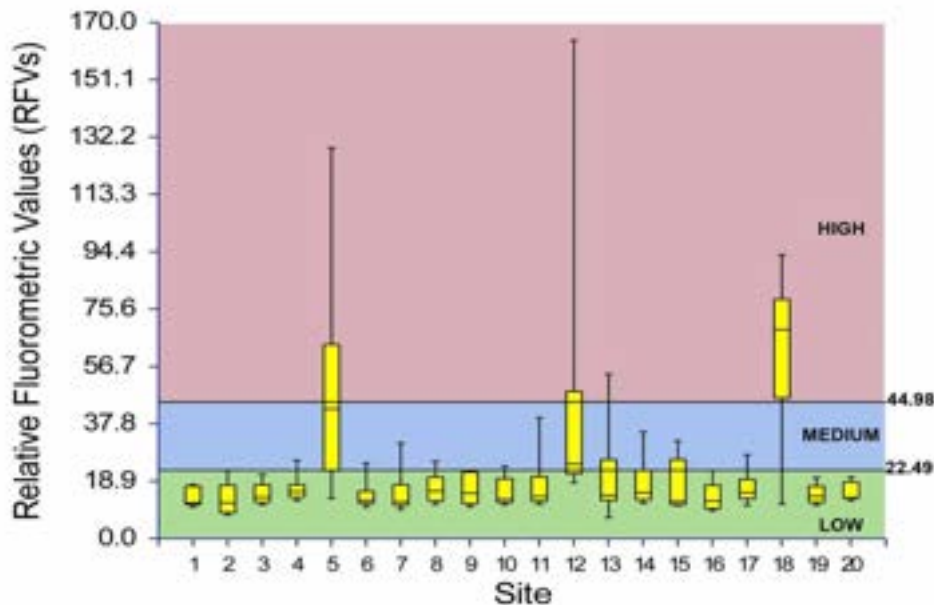
Figure 10. Fluorometry Results per Site

Box plot shows the full range of results from all 9 sample dates. Whiskers extend to the highest and lowest values recorded, and the median for each data set is represented by the horizontal center black line.

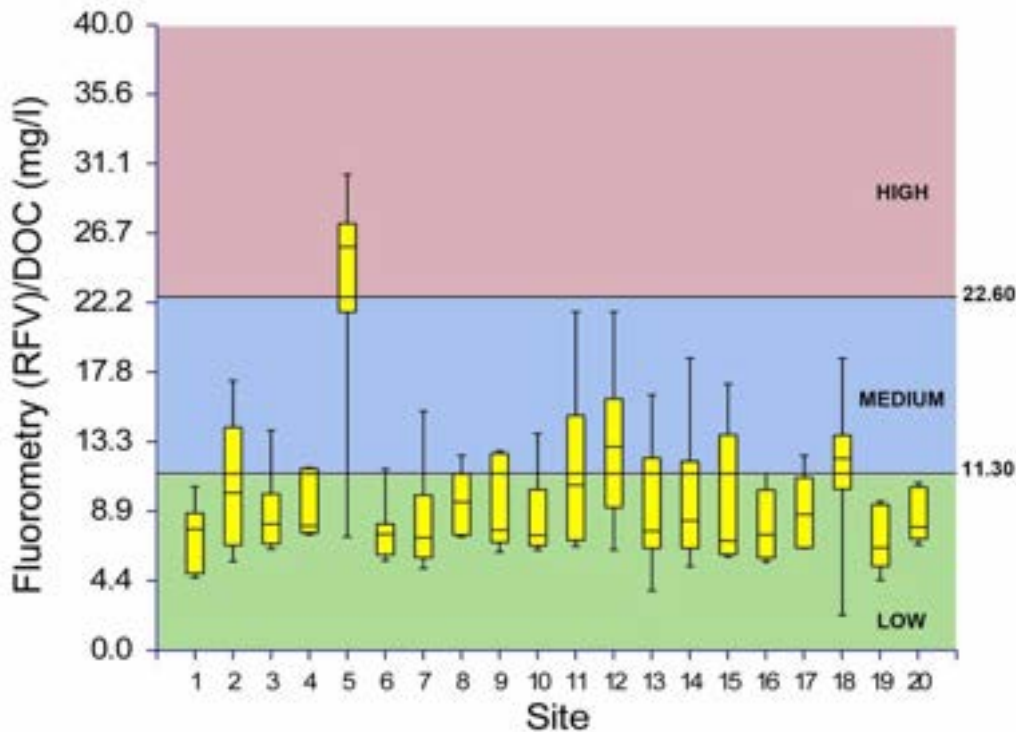
Figure 12. F/DOC Results by Site

A Fluorometric to Dissolved Organic Carbon ratio (F/DOC) was calculated using in-situ fluorometric values in RFVs along with DOC results provided by ME Laboratories in Kalispell. The five highest overall F/DOC (mg/l) values (30.43, 27.29, 27.16, 25.90, & 22.56)—the first four considered conclusive for OBAs—occurred at Site 5: Viking Creek in spring, summer and fall, which also reported three medium values and only once dropped into the low range. Site 11: Brush Bay and 12: Lazy Channel each had values just below the high range in the spring (21.64 & 21.65 respectively), followed by 14: Central Beaver Bay (18.68), 18: Dog Bay State Park Seep (18.67), 2: City Beach Seep

Box plot shows the full range of results from all 9 sample dates. Whiskers extend to the highest and lowest values recorded, and the median for each data set is represented by the horizontal center black line.

The highest F/DOC value of the study at the reference Site (16: Midlake) was 11.30, which was used to set the top of the low range of F/DOC values. As with RFVs, the reference site highest F/DOC value was doubled (22.60) to set the top of the medium range. F/DOC ratios ranging from 0 to 11.30 were considered low, 11.31 to 22.60 medium, 22.61 and above equated to a high/conclusive reading of OBAs in sampled water. F/DOC ratios in this study were generally elevated in seeps and creeks as compared to the reference site. Based on F/DOC values, it is concluded that Site 5: Viking Creek shows conclusive signs of wastewater contamination.

As a comparison, an F/DOC value above the threshold set in the 1985 study was reported at Site 18: Dog Bay State Park Seep (417), and elevated F/DOC values—not far below the threshold—were reported at Site 2: City Beach Seep (340) and Site 5: Viking Creek (286) (Jourdonnais *et al*). Although the fluorometric equipment differed from the earlier study to this study, the results suggest that F/DOC values of this study remain high in areas with previously high readings, and that values at several additional sites have increased.

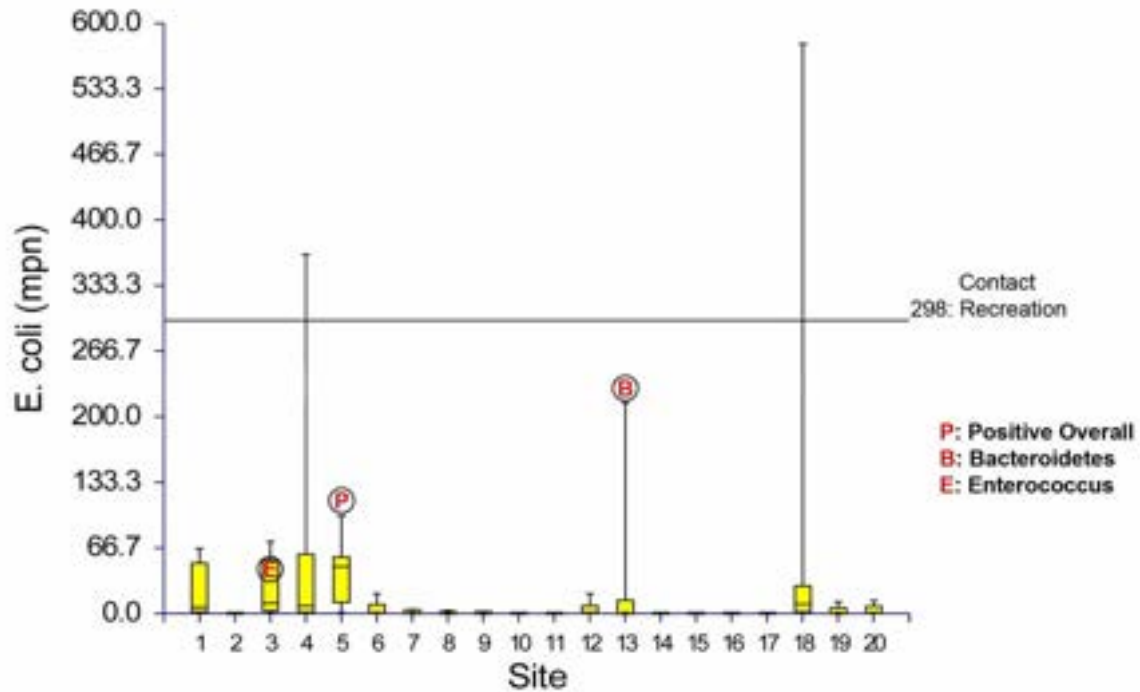
Figure 13. *Escherichia coli* Results and Human DNA Biomarker by Site

Box plot shows the full range of results from all 9 sample dates. Whiskers extend to the highest and lowest values recorded, and the median for each data set is represented by the horizontal center black line.

A *trace* result means the biomarker was found in low quantities, but above the detection limit. One *trace* finding for *Bacteroidetes* was reported on July 6 at Site 13: Lazy Bay. *Trace Bacteroidetes*, even with a negative *Enterococcus* is considered significant and also suggests certain fecal pollution. One *trace* finding for *Enterococcus* was reported on August 17 at Site 3: City Beach Bay. *Trace Enterococcus* with a negative *Bacteroidetes* suggests possible re-growth of bacteria.

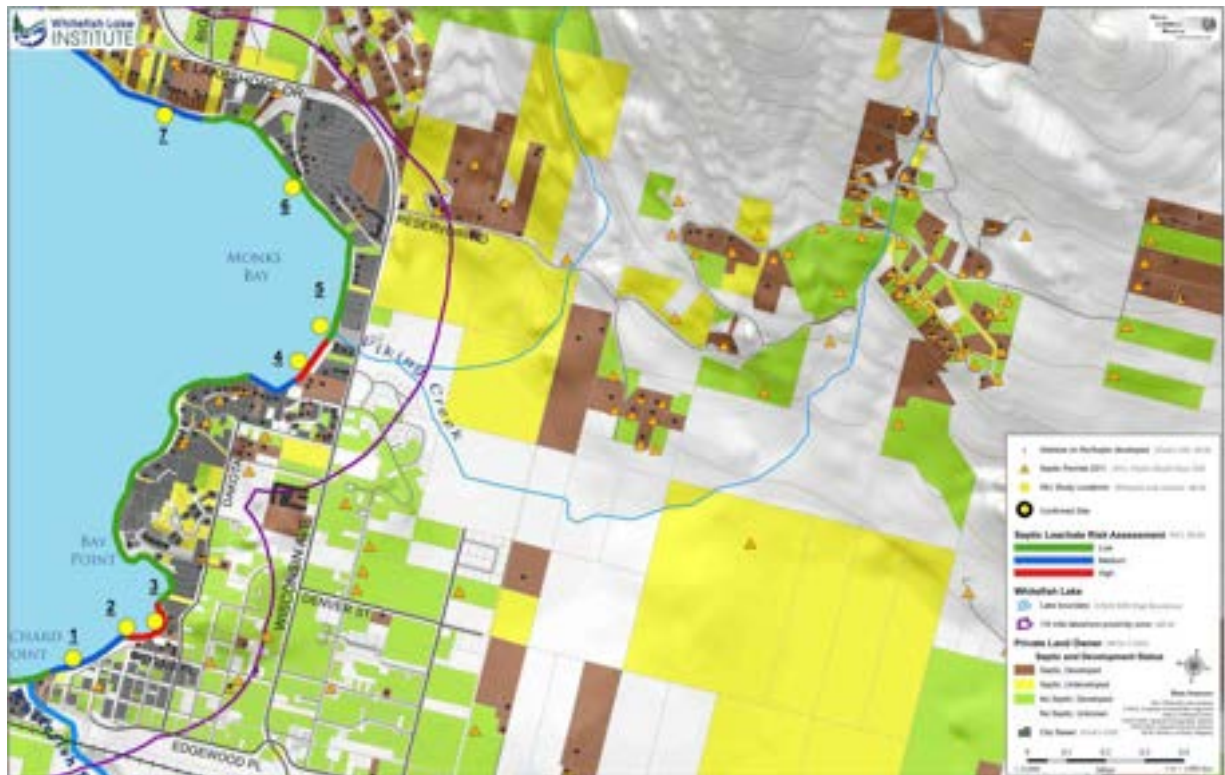
Figure 25. SE. Monk's Bay & Viking Creek

Groundwater at Site 4: SE Monk's Bay, south of Viking Creek is influenced by Wildwood Condominiums and several private homes. The area is fully available for

The City of Whitefish Wastewater Utility Plan noted some stormwater issues in this area. First, the main stormwater conveyance culvert that moves water from the Murdoch Nature Conservancy area is often clogged with debris causing water to back up in the Conservancy area. The Montana Department of Transportation maintains this culvert. East of Murdoch Lane is the main culvert that transports drainage from Suncrest and Mountain Harbor Subdivisions across East Lakeshore Drive to the lake. Some of the flow at this section actually drains under the culvert rather than through it. The Crestwood Subdivision, which once included some wetlands, has high groundwater and an inadequate drainage system (Montgomery *et al*, 2006).

Further complicating issues in this area is the potential impact of Wisconsin Avenue structures on groundwater flow migration. Flows may have been obstructed and/or rerouted as a result of building footprints. Also potentially influencing these sites are the

Most probable scenario: Chronic contamination at this site is likely the result of a localized sewer system infrastructure failure.

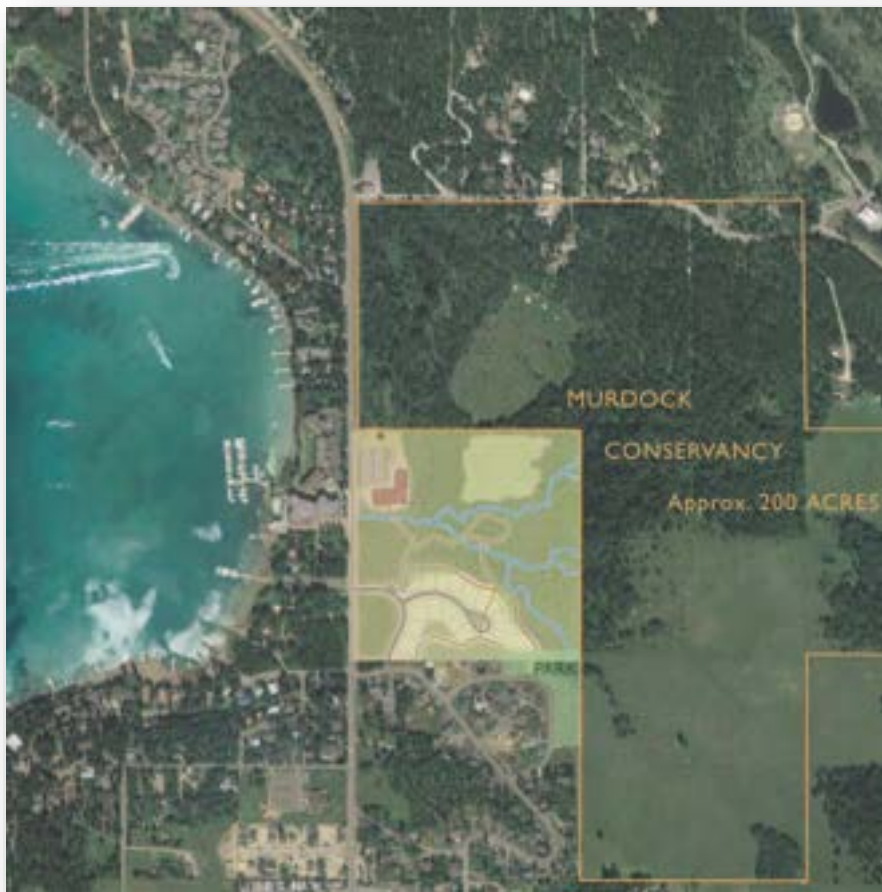
Photo 5. WLI's Viking Creek Wetland Preserve

28.82 acres of the undeveloped land was gifted to WLI for conservation, wetland restoration, and public education (Photo 5). The wetland has a perched water table on silty to lean clay soils with low vertical hydraulic conductivity, however horizontal transmissivity is likely pronounced as a result.

Considering the buffering capabilities of the Viking Creek wetland complex that WLI owns and manages, along with the Murdock Nature Conservancy to the north and east, it is reasonable to assume that any wastewater or stormwater issues from the upper Viking Creek drainage would be mitigated (treated) prior to conveyance to Viking Creek.

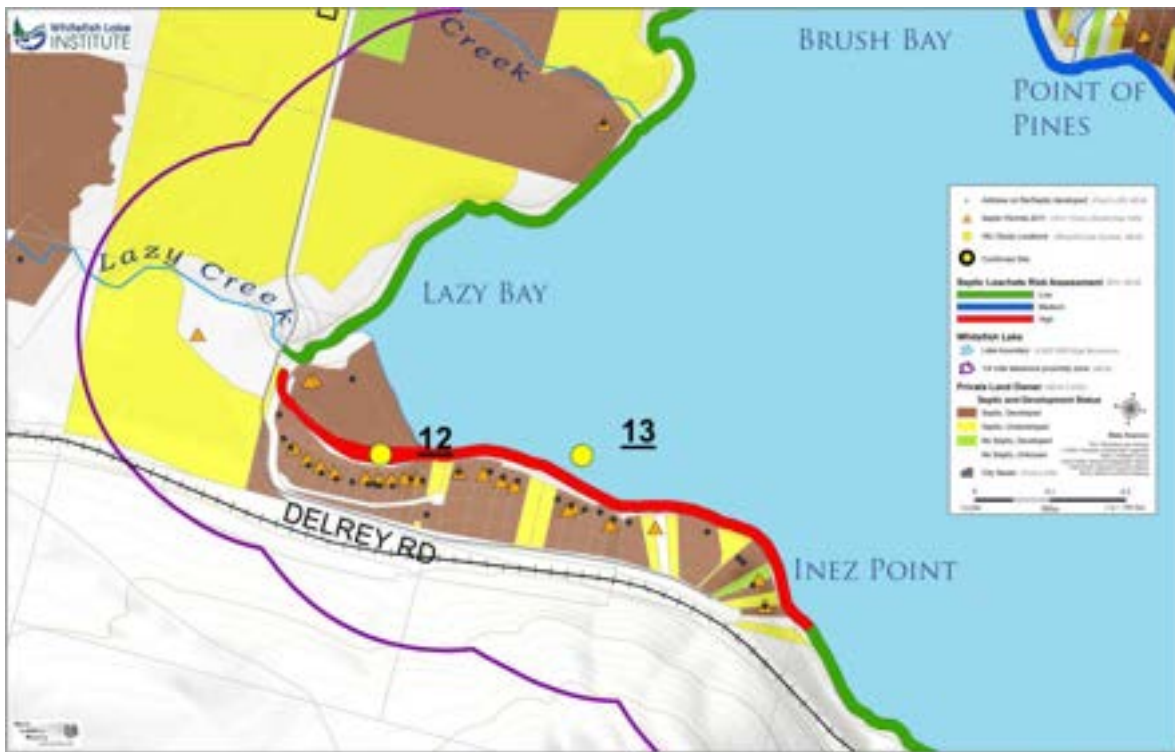
Figure 26. Lazy Bay & Vicinity

Groundwater at Site 12: Lazy Channel and Site 13: Lazy Bay is influenced by the subdivisions adjacent to the bay. The Lazy Bay and Inez Point subdivisions—on the north end of the lake has a high density of septic systems in an area of limited soil suitability for septic systems, and in close proximity to the lake. There is no access to the City sewer infrastructure in this area. There are only 2 homes situated on Lazy Creek. Lot slope in this area varies from 11% to 50%. This area has a mix of homes built since the first subdivision approval in 1976 suggesting that—unless since replaced—there are septic systems up to 36 years old. Site 13: Lazy Bay had generally low to medium fluorometric and F/DOC values, but had a positive result for the human DNA biomarker *Bacteroidetes*. Site 12: Lazy Channel had the single highest fluorometric reading (164.10) and F:DOC values from medium to just below the high range.

Lazy Creek flows naturally into the lake on the north side of the island, but is diverted by a culvert to the channel. Lazy Channel has low input flows resulting from the angled culvert on the input side and is influenced by lake inundation effect on the output side.

Most probable scenario: Aging septic systems have begun failing and are contributing septic leachate to groundwater and the lake.

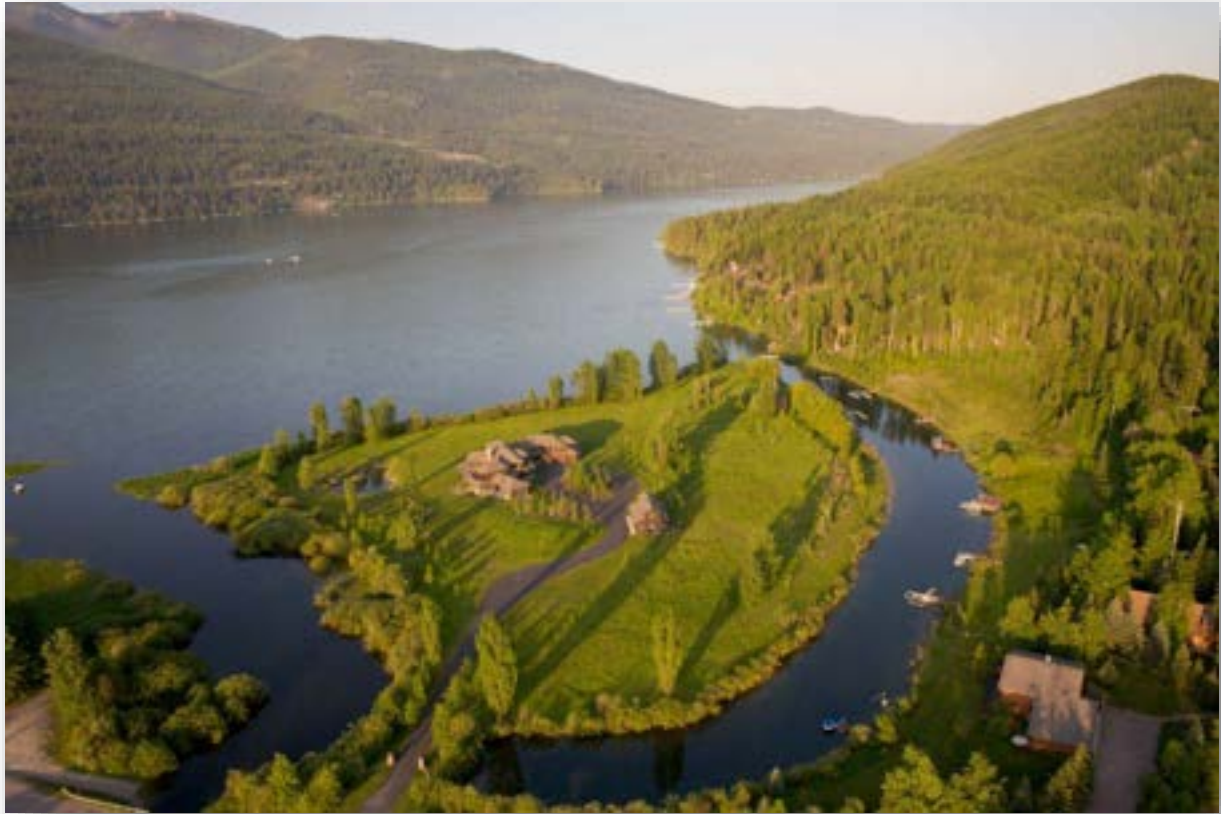
Photo 7. Lazy Bay & Lazy Channel (courtesy gravityshots.com)

Lazy Bay is also home to a small, little known, county owned public access/park listed in county records as Lake Park Addition Park when it was created. The park became county property in 2009, also the year that a county planner submitted to the county park board a proposal for improvements such as public parking, handicap-accessible parking, trails, and a vault toilet to replace the pit toilet.

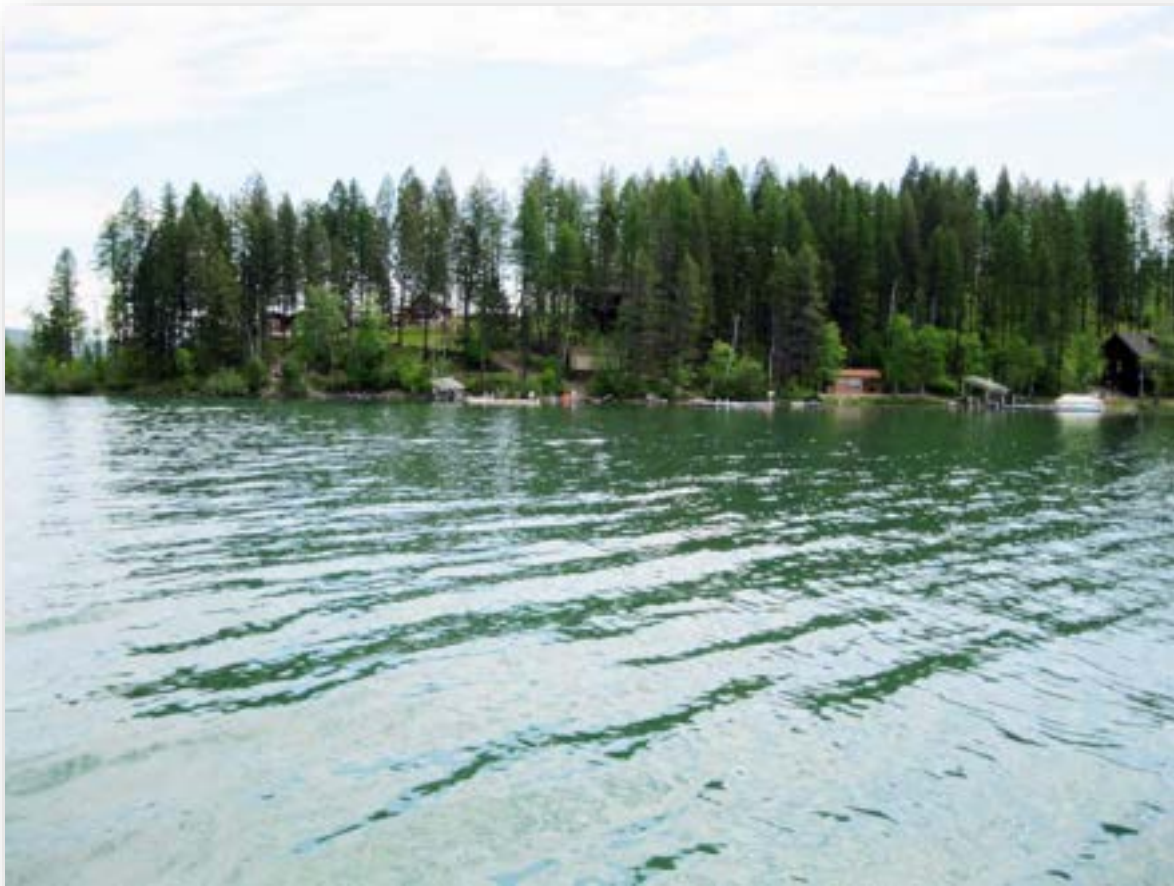
Photo 8. Dog Bay (WLI stock photo)

Site 18: Dog Bay State Park groundwater is influenced primarily by the multi-phased Lion Mountain Subdivision. The subdivision was initially developed in 1973. It is located on the western edge of the City of Whitefish, and consists of 123 lots ranging from one-half acre to over twenty acres, of which 17 lots are connected to the city sewer system. Of those 17 lots, 11 homes have been built and tied into the system. The remaining 106 lots have conventional septic systems ranging in age from 7 to 38 years. The terrain is considered forest mountainous with ranges in elevation. Septic system suitability is very limited. There are about nine miles of private paved roads throughout the nearly 800 acres of the development.

Most probable scenario: Aging septic systems from one or more of the first five phases of development have begun failing and contributing septic leachate to groundwater.

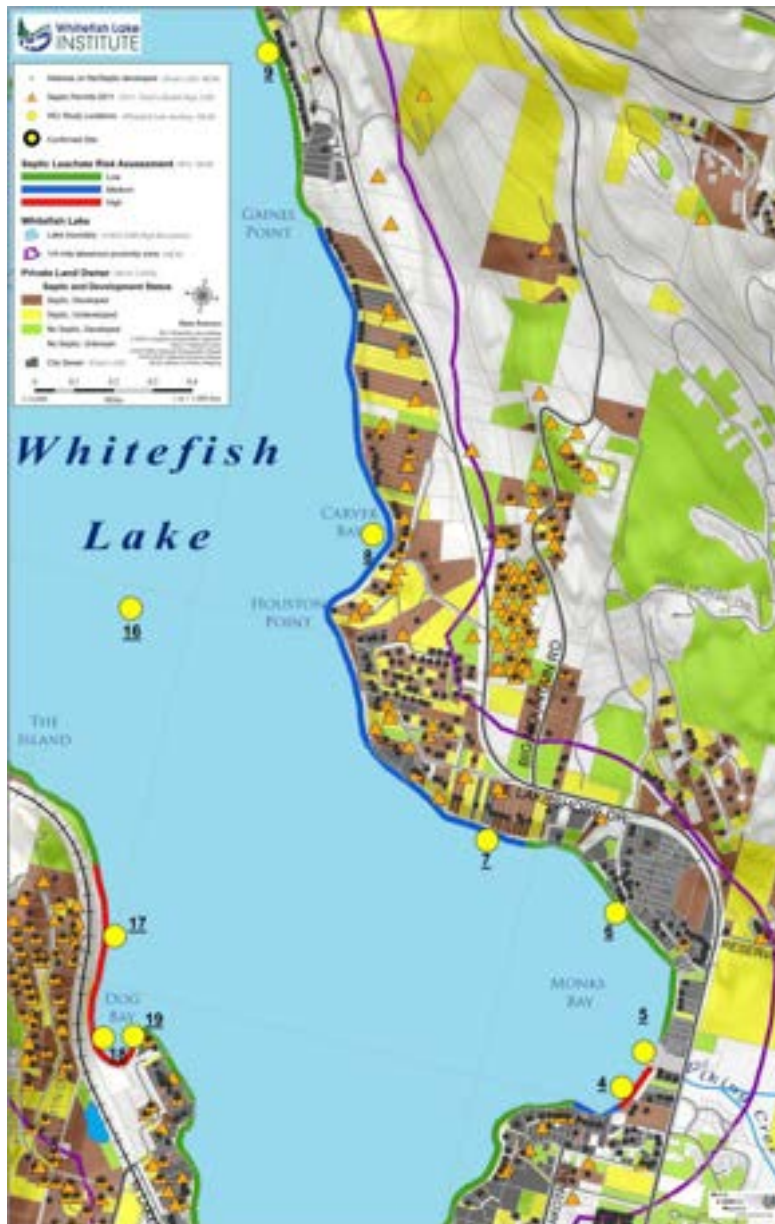
Figure 29. East Shore

Based on analysis of GIS data, this area on the east shore of the lake is influenced by a high density of individual septic systems in close proximity to the lake. Homes range in age from the earliest built in 1934, to recently built homes. Included in the area are Whitefish Lake Summer Homes, and Carver Bay and Houston Point subdivisions. Homes in this area vary in size from small single family homes to several thousand square foot homes for multiple occupants. Several homes in the area are serviced by the City sewer system, but many remain on individual septic systems.
